# THE DOME OF THE ROCK IN JERUSALEM

A Description of its Structure & Decoration

ERNEST TATHAM RICHMOND

FELLOW OF THE ROYAL INSTITUTE OF BRITISH ARCHITECTS  
CONSULTING ARCHITECT TO THE NOBLE SANCTUARY IN JERUSALEM

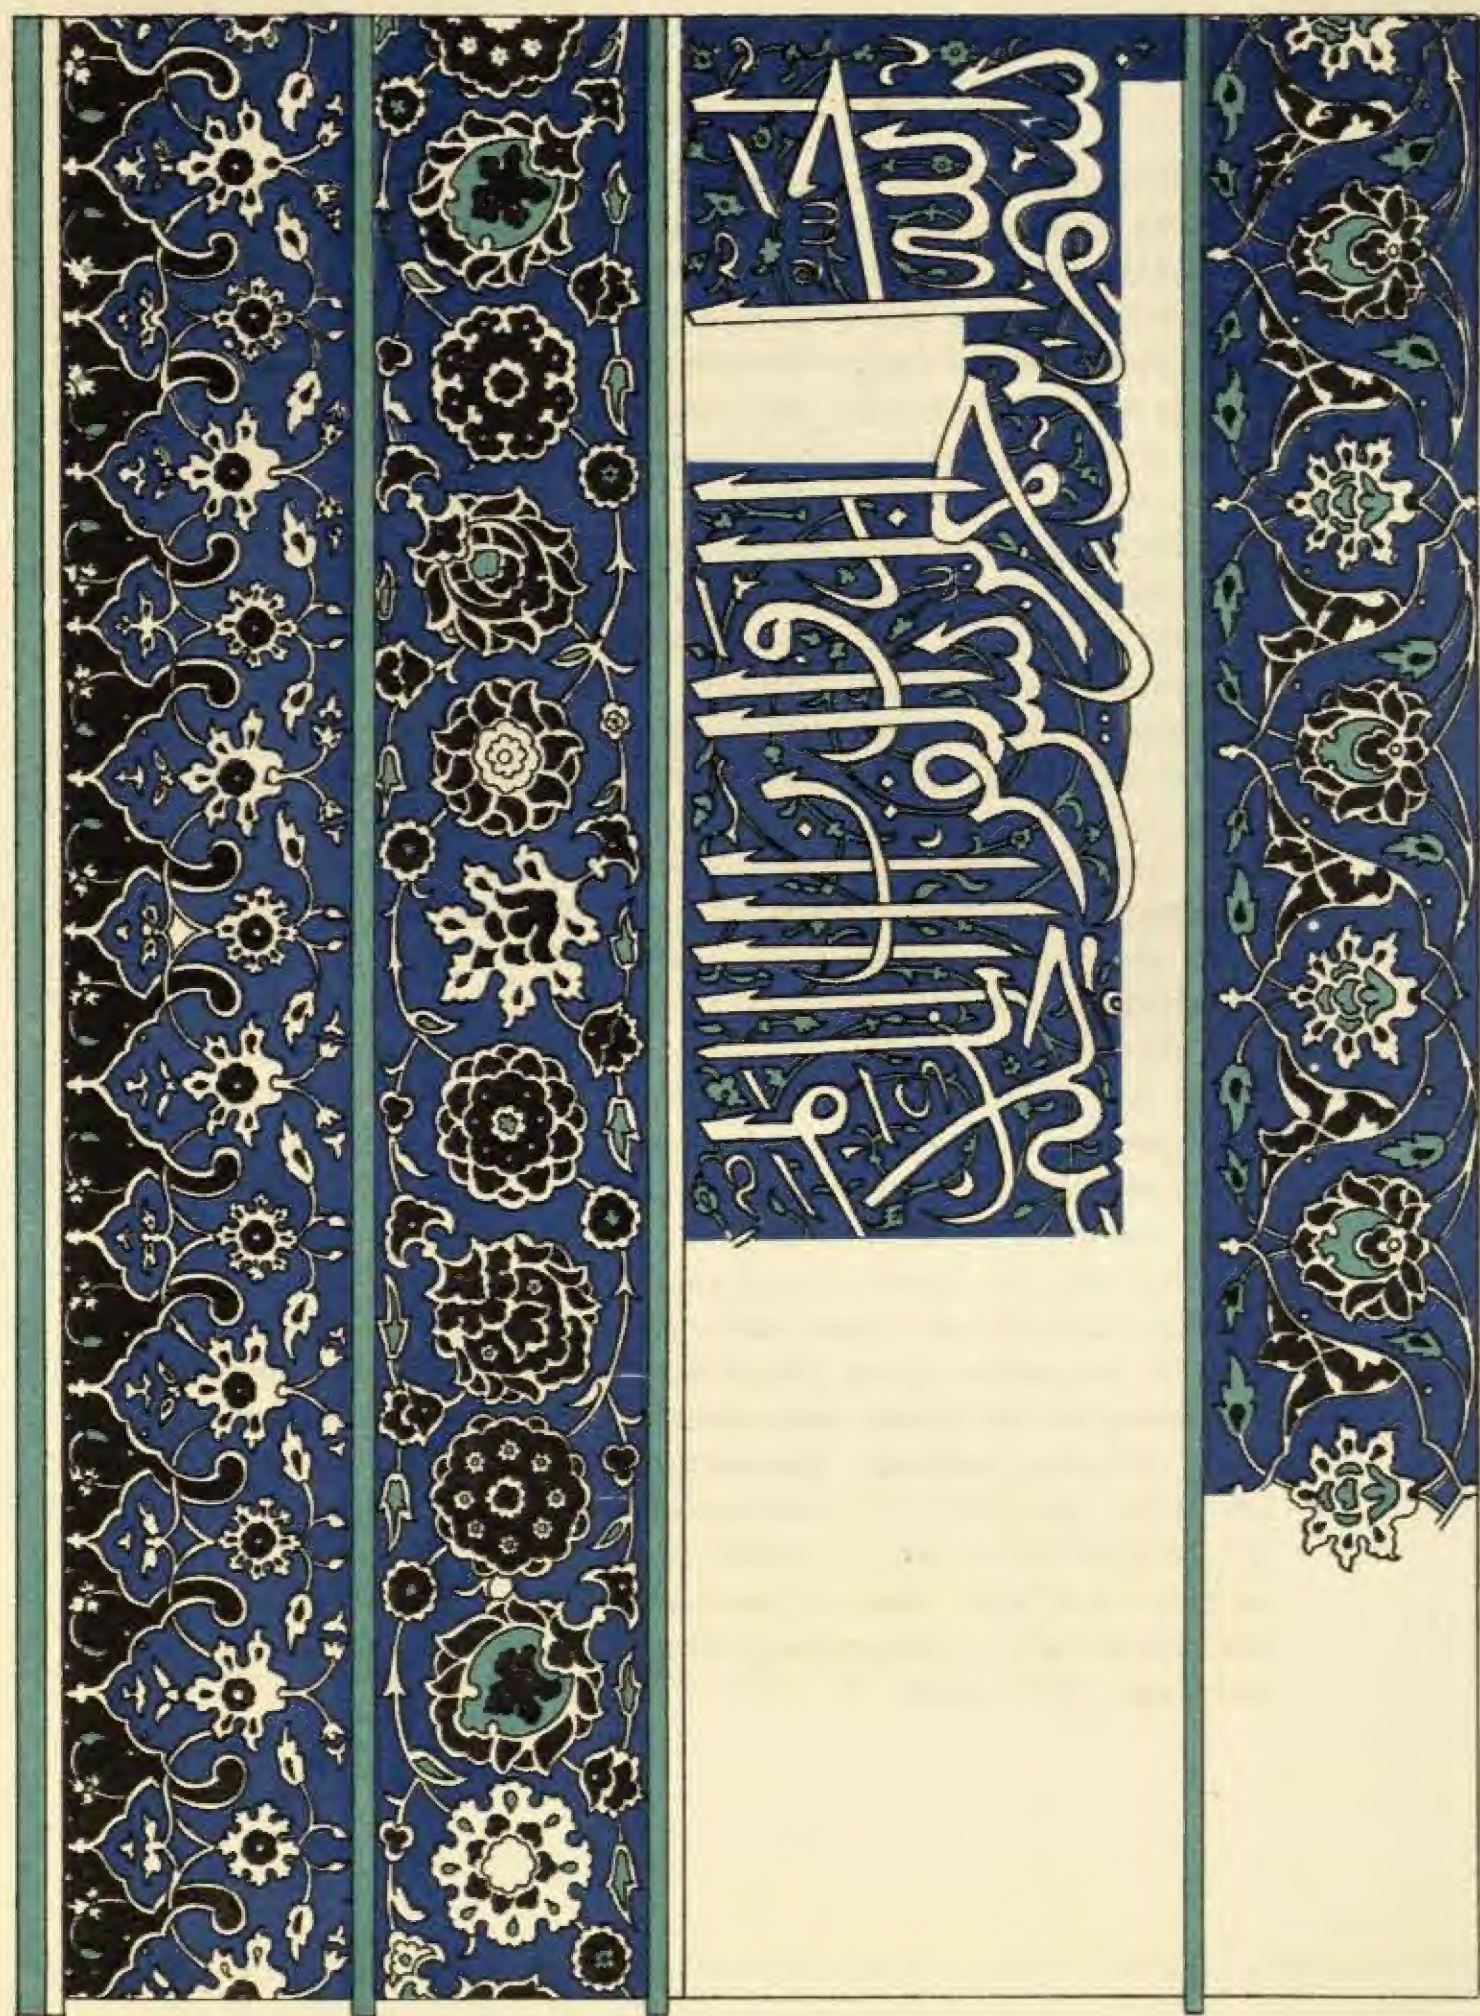
Fig. 41. Parapet wall : suggested arrangement of the tile decoration in the early 16th century

Scale 1:12.5

particular care the manner of its use. It is possible, then, that the panel treatment of the parapet wall was introduced sometime between 1842 and the early nineteenth century, say 1818, the date found on many tiles, and that at an earlier period there was a design for the parapet wall that included as one of its elements the pattern shown on Fig. 40 a pattern which, in view of its scale, is well adapted for a position so far from the eye. The tiles of this design are  $20\frac{1}{2}$  centimetres wide and 23 centimetres high. A second element in the design was without doubt the battlemented pattern shown in Fig. 23 and already described in the second section of this chapter. The tiles forming this pattern are 25 centimetres square. A third element was the great sixteenth-century Koranic inscription already described and referred to as having been found in the store-houses of the Haram. This inscription, the remains of which are in the Haram Museum, is made up of three rows of tiles 25 centimetres square and one row  $10\frac{1}{2}$  centimetres high and 25 centimetres long. A fourth element probably consisted in a row of glazed bricks set on edge above the cornice. A row of such bricks is found below the cornice, and, as is seen everywhere, they were used to mark structural lines. These bricks are 10 centimetres high. A fifth element was probably a band of tiles ornamented with the great floral pattern seen to a small scale in Fig. 41. These tiles have already been described in § 2. If these elements are superimposed and separated from one another by turquoise-coloured tiles of the thickness (3 centimetres) found in many parts of the building, the total height of the composition is  $249\frac{1}{2}$  centimetres. The height of the parapet wall from the top of the cornice to the top of the highest blue band is 250 centimetres, a difference of  $\frac{1}{2}$  centimetre, which is accounted for by jointing.

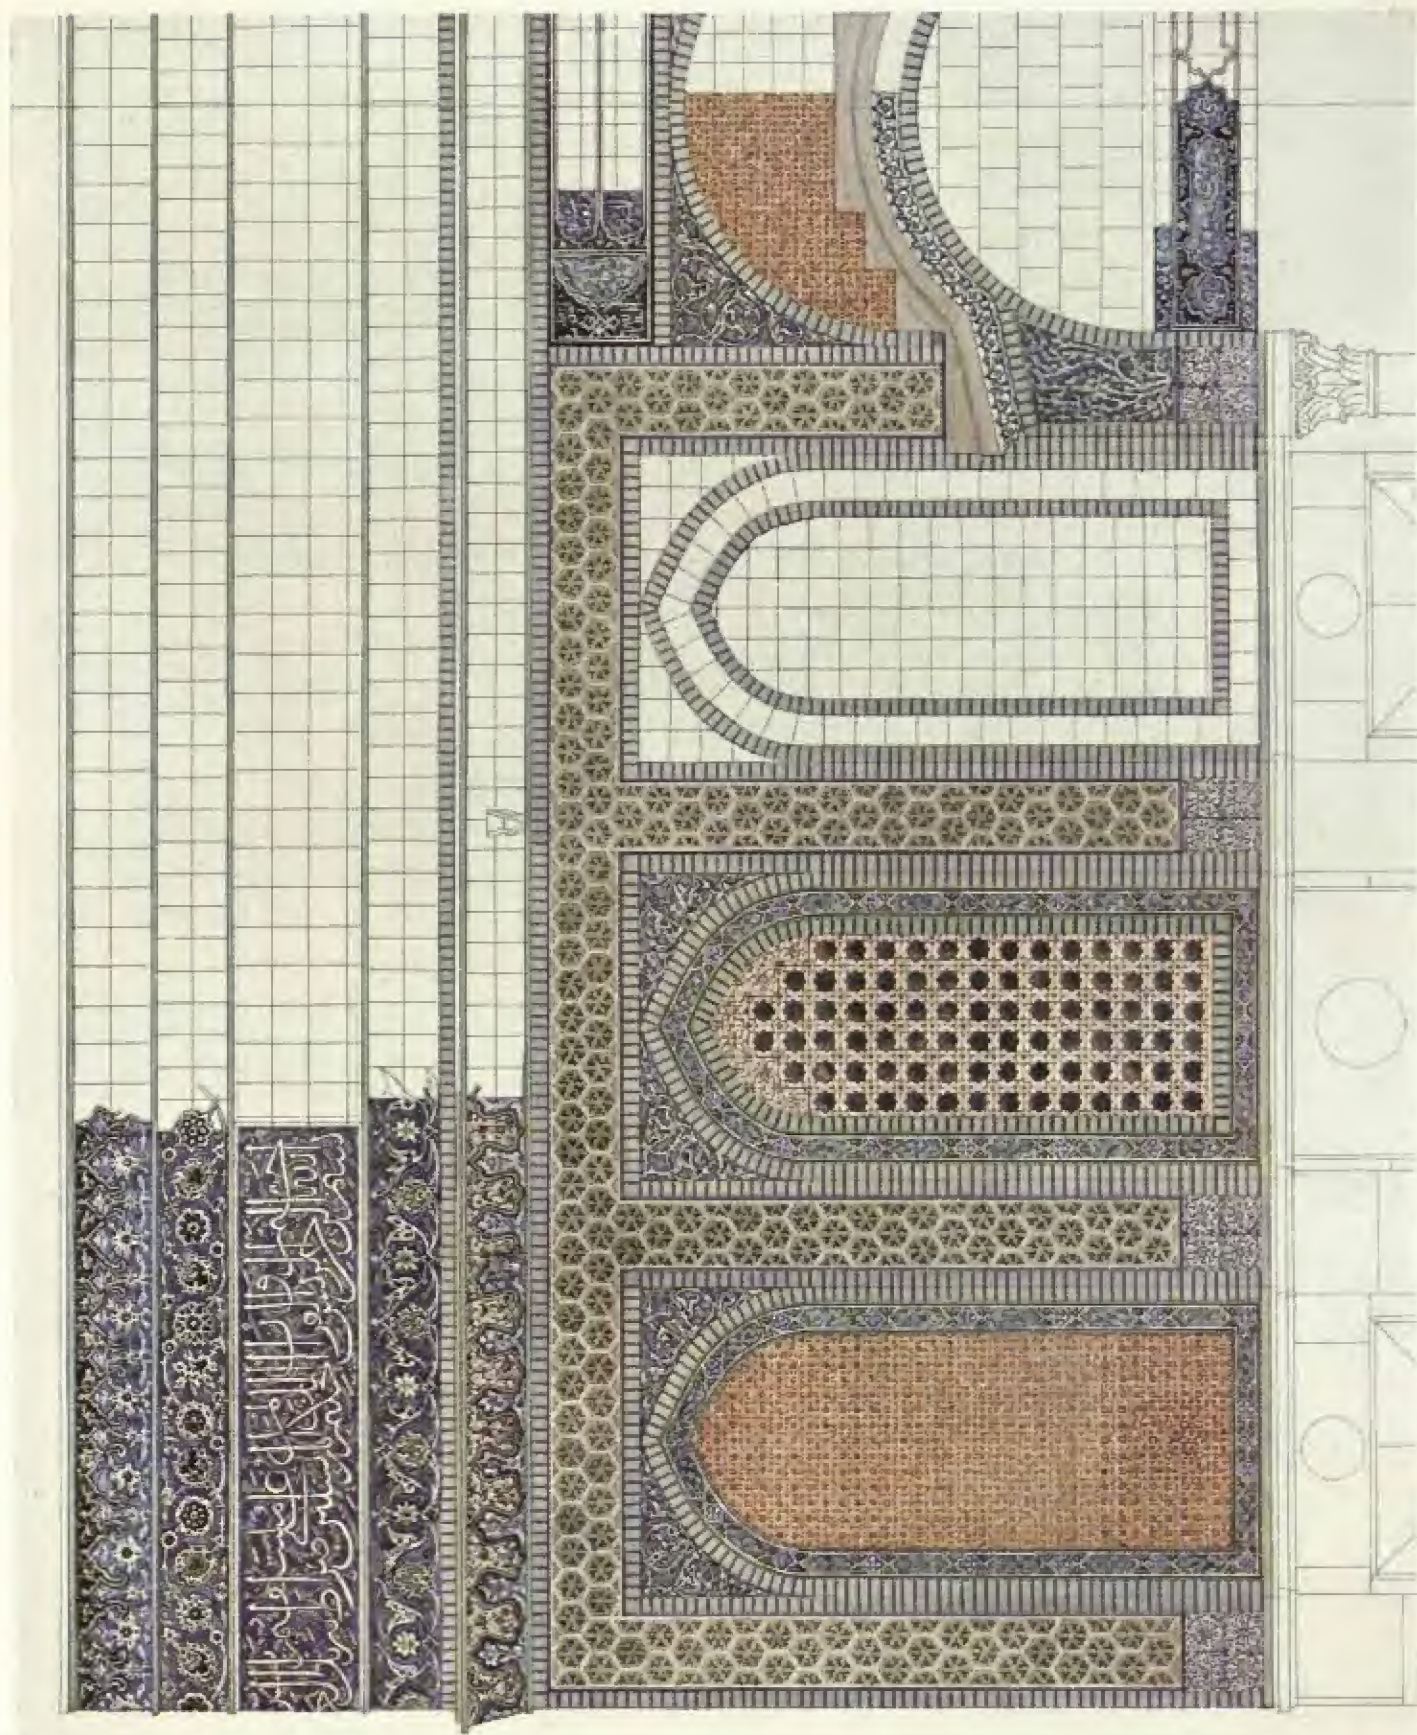
Fig. 42. Conjectural restoration

In this restoration (Fig. 42) both fifteenth- and sixteenth-century tiles have been used. The illustration is intended to represent what this façade might have been like after the great repair carried out in the first half of the sixteenth century. The parapet wall is covered with sixteenth-century tiles, set in four bands; at the top a battlemented band and between the battlements and the cornice, the great Ya Sin inscription of Suleiman the Magnificent bordered at the top and at the bottom with great floral scrolls. The cornice, the piers, and

the architrave are filled with sixteenth-century tiles, as are the spandrels and the portico, the blind bay being filled with fifteenth-century tiles. This drawing is only intended to illustrate in broad lines some of the conclusions reached from the examination that has been made. It would not be hard to justify a more elaborate reconstruction. Inscribed panels might be placed in the architrave above the windows and also in the blind bay and instead of only turquoise-blue quoins to the windows enclosing pierced tiles of black on white, aubergine quoins might be used for some windows, as well as other varieties of pierced tiles (see Figs. 29 and 30).

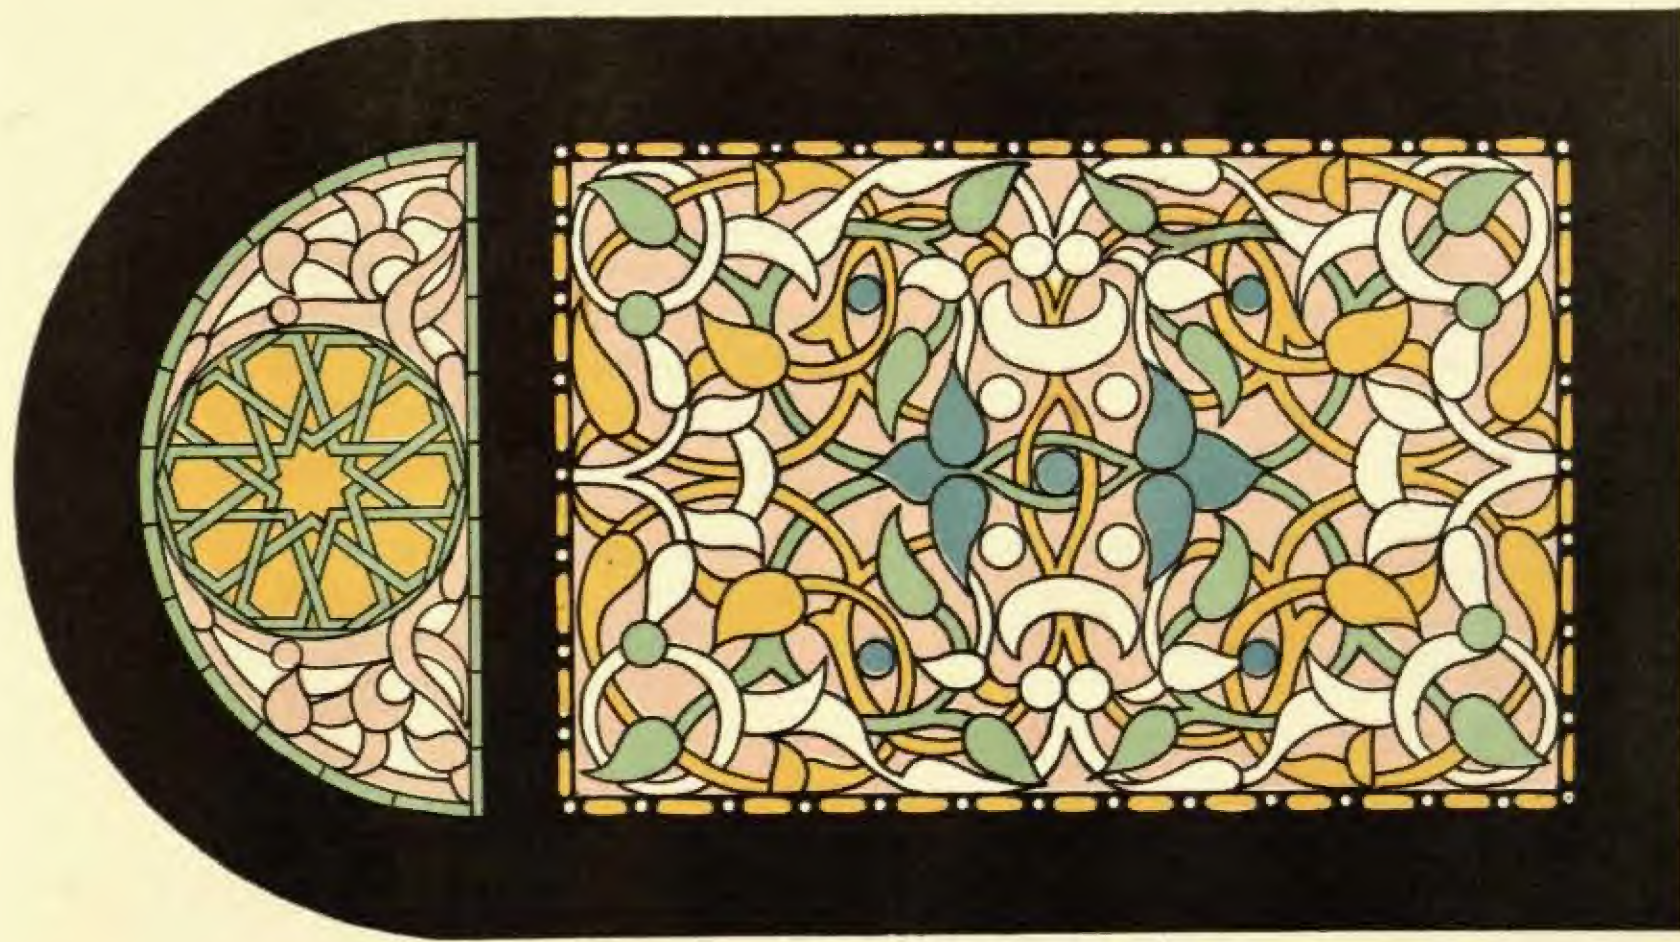
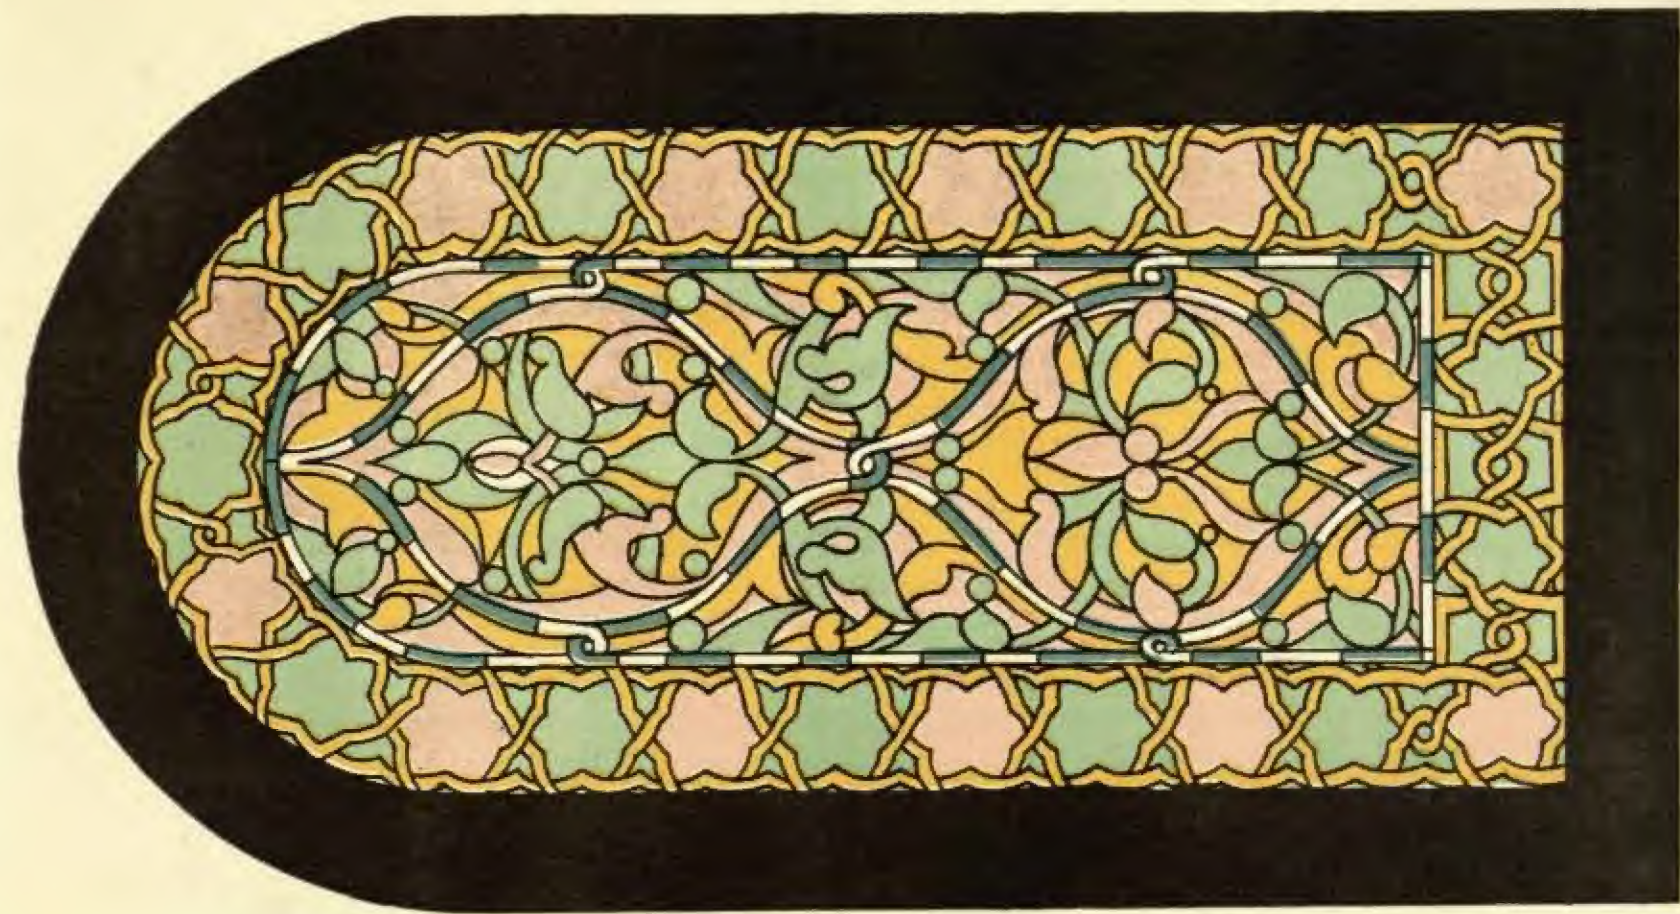
Figs. 67-8. Two of the windows in the drum  
Scale 1:15.13

The oldest work is found in the drum. Of the sixteen windows in the drum six appear to date from at least as early as the fifteenth century, possibly the fourteenth. The others are of various dates and several are as recent as the end of the nineteenth century, when they were made just before the German Emperor's visit. In the octagon none of the windows are earlier than the sixteenth century. Some are quite modern, others date from 1874, and others again from the eighteenth and early nineteenth centuries. The plaster is set in wooden frames about eight centimetres

square in section. The designs of the oldest windows in the drum consist either of geometrical patterns or of interlacing floral scrolls of different colours. Figs. 67 and 68 illustrate two of these windows. The panes are large compared with those of the sixteenth-century windows, and the lines of plaster that take the place of the lead in our windows are narrow, barely more than one centimetre wide. The glass is set at a distance of from six to seven centimetres from the outer surface of the plaster. On the inside the glass is held in place by a fillet of plaster, bevelled on each edge, and about one centimetre wide and one centimetre thick, covering the joints between the panes. The sixteenth-century windows are made differently. The pattern is, as in the earlier windows, fretted in the plaster, but the glass is set on the outer surface. The panes are much smaller than in the earlier windows. The tunnels, through which the light trickles, are often wider on their inner than on the outer openings, and form cones sloped slightly downwards. The inner surface of the plaster is not flush over the whole area of the window, but is in two planes, one raised a little above the other; the main lines of the design fill the upper plane and the subsidiary lines the lower plane. The colours used are red, blue, green, yellow, and white. The older glass is streaked and filled with bubbles. The more modern windows are in a worse condition than the older windows, partly because they are in more exposed positions, but chiefly because they are not so well made. The older plaster is much harder and seems to have marble dust mixed with it; but analysis is needed to find out the exact composition.
